Utah OSHA Compliance Assistance Newsletter

(Summer 2003)

UOSH Compliance Assistance Newsletter (Summer issue 2003)

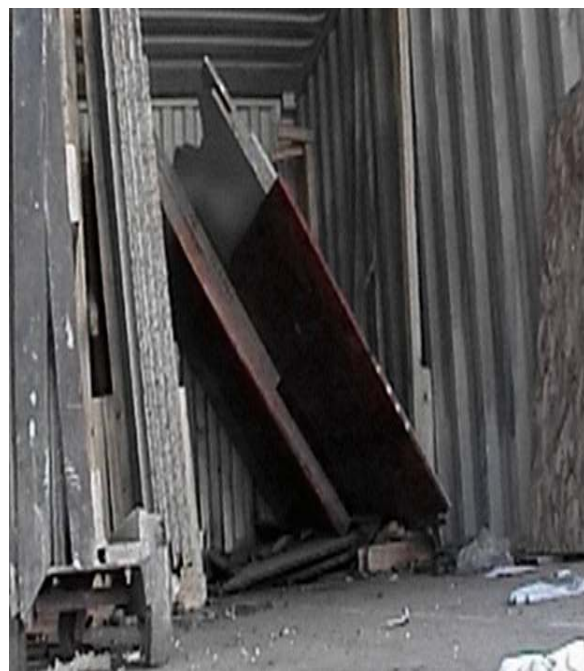
Lessons Learned #1

Accident Type	Crushed by stone slabs	Employer Safety and Health Program?	No
Weather	Dry, Cool	Training & Education program for employees?	No
Type of Company	Interior decorative stone importers and installers	Craft of Deceased employee	Laborer
Size of Work Crew	Five	Age/Sex	30/Male
Union or non-Union	Non-Union	Experience at this type of work	6 months
Worksite inspection program	None	Time on Project	1 hour
Designated Competent Person on site?	None

Workers were unloading a shipment of stone from a cargo container/trailer. They had successfully unloaded all of the small containers. The remaining three wood shipping crates each held 10 stone slabs, approximately 6 ft. X 9 ft. X 7/8 inch, each weighing about 650 pounds. Two of the crates were on the left side at the back of the trailer, the other was on the right side at the back of the trailer. This uneven weight distribution caused the cargo trailer to lean to one side. Because the crates were too heavy to move with the equipment available, the workers were trying to move one slab at a time to the back of the trailer where it could be picked up with a forklift. They started with the crate on the right. After successfully moving the first slabs, the next slab had a small crack in it. When they started to move the slab, it fractured and fell. Because the trailer was leaning, the remaining slabs fell over onto the workers, pinning three of them. One of the workers was killed.

1. Pre-plan work, to identify the hazards of the work to be performed, and to identify the work practices and equipment necessary to perform the work safely .
2. Train the employees in the work practices necessary to perform the job safely.
3. Provide mechanical handling equipment appropriate to the task.
4. Provide additional supports to level the trailer and prevent it from tipping (not only side to side, but also front to back - due to the weight involved with stone, the trailer can be tipped over not only on its side, but also on either end).

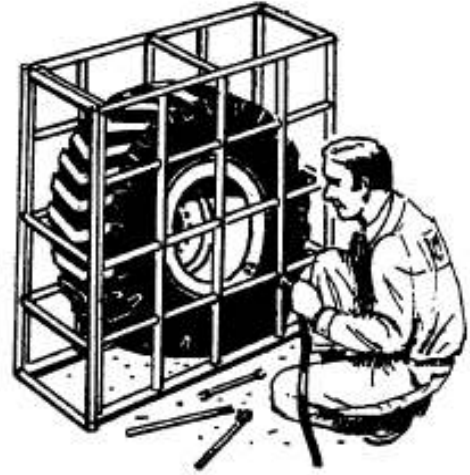
Lessons Learned #2

Accident Type	Head Injury- Non Fatal	Employer Safety and Health Program?	Yes
Weather	Clear	Training & Education program for employees?	Yes
Type of Company	Tire Dealer	Craft of Deceased employee	Tire Changer
Size of Work Crew	1	Age/Sex	20/Male
Union or non-Union	Non-Union	Experience at this type of work	1 years
Worksite inspection program	None	Time on Project	1 hour
Designated Competent Person on site?	N/A

The employee had removed the damaged tire and replaced it with a new tire and tube after inspecting the rim. In preparing to seat the bead, he placed the tire and rim on the ground and began to inflate the tire tube with 130 psi air without a tire gauge when the tire tube burst causing the tire bead to rupture. The employee was over the tire when the burst of air caused the tire and rim to rocket into the air. The rocketing tire propelled the employee into the air about 10 feet and was found on the ground next to his truck with severe head injuries.

1. Maintain a safe distance while inflating heavy equipment and truck tire to stay out of the trajectory of the rim.
2. Place tires in a restraining cage or mount on the vehicle before seating the bead the during inflation.
3. Use clip-on air chuck and extended in-line air gauge so the air pressure can be monitored during the initial inflation of the tube according to the tire manufacturer's warning instruction.
4. Train employees on the safety procedures in mounting and inflating tube tires.

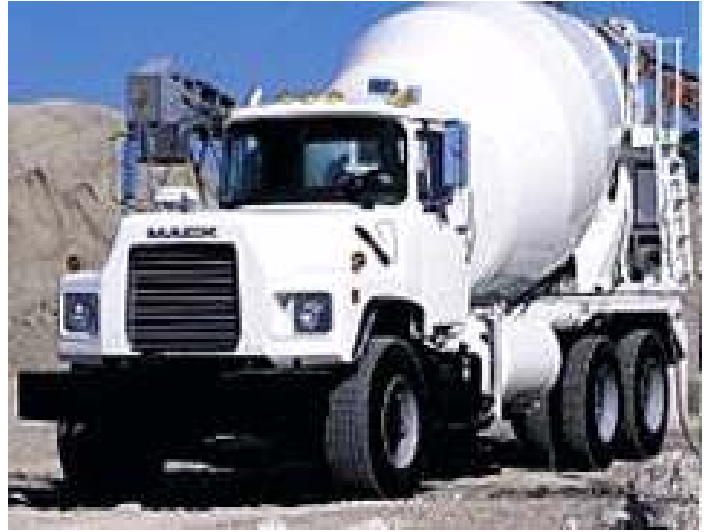
Lessons Learned #3

Accident Type	Fatality	Employer Safety and Health Program?	None
Weather	Clear	Training & Education program for employees?	None
Type of Company	Ready-mixed concrete	Craft of Deceased employee	Truck Driver
Size of Work Crew	1	Age/Sex	37/Male
Union or non-Union	Non-Union	Experience at this type of work	3 years
Worksite inspection program	None	Time on Project	1 hour
Designated Competent Person on site?	N/A

An employee was cleaning concrete residue from the discharge chute and from the fins inside of the drum of a ready mix cement truck using a spray gun. The employee finished cleaning the discharge chute and climbed on to the platform at the top of the cab, preparing to clean the drum fins. Apparently, he stepped on the discharge cowl to gain better access to remove the concrete, lost his balance, and slid into the rotating drum receiving fatal injuries.

1. Use a positioning device system or a fall restraint system while working on the platform.
2. Train employees in recognizing fall hazards and procedures necessary to perform the job safely.
